Appendix A. Wiring details

Appendix B. Summary of sites

Appendix C. Tension vs. hydraulic conductivity curves

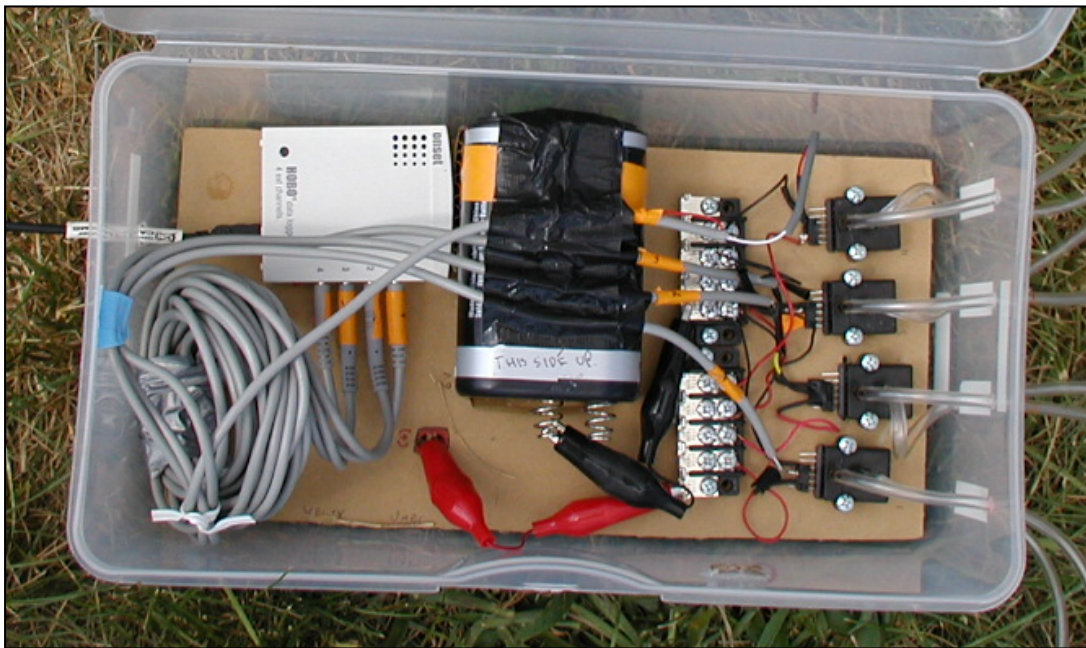
Figure A-1. Layout of wiring components in plastic box.

The pressure transducers and barrier strips were mounted on a very thick piece of cardboard with screws. The cardboard was placed inside of a clear plastic flip-top box (approx. 30 cm x 15 cm x 7 cm) (Figure A-1). Holes (.953 cm (3/8”) drill bit) in the side of the box allowed the tubing and USB cord to be connected while the box lid was closed. The battery was placed in a cut out section of the cardboard so that it would not roll around.

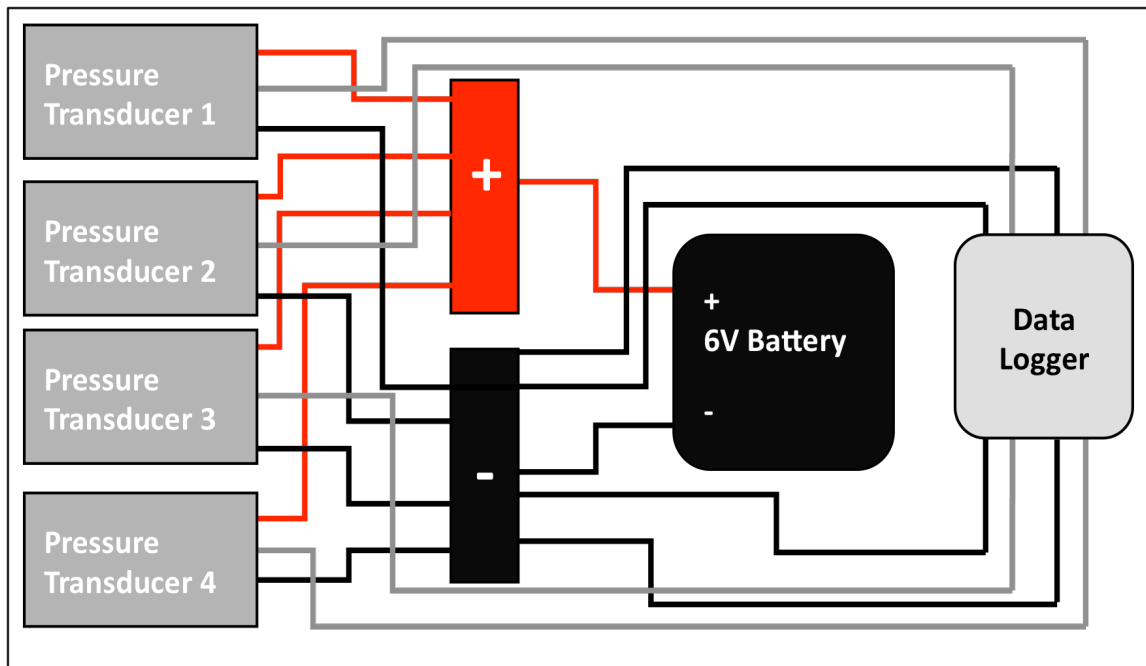
Figure A-2. Diagram of wiring connections.

First, three wires were soldered to each of the IC socket halves: an approximately 10 cm long red wire on pin 2, one of the white wires from the data-logger stereo cables on pin 3, and an approximately 10 cm long black wire on pin 4 (pin numbers refer to the corresponding pressure transducer pin). Heat shrink wrap was applied to the red and black wires where they were soldered to the socket so that no contact would occur between the pins.

The other end of each red wire was connected to one of the screws on one of the barrier strips on the opposite side from the bus. The other end of each black wire was connected similarly to

the other barrier strip. In addition, the black grounding wires from the data logger's stereo cables were connected to this barrier strip (under the screws on the side with the bus). Connecting the grounding wires from the data logger completes the circuit to give the data logger a reference for the voltage that it is receiving.

The alligator clips were clipped onto the edge of each bus, with the red set of clips connecting the positive terminal of the battery to the barrier strip two which the red wires were connected and the black set of clips connecting the negative terminal of the battery to the barrier strip with the black wires attached. The clips were disconnected when not making a measurement.

Figure A-2 shows the necessary wiring connections between the data logger and the pressure transducers.

The differential pressure transducers used were Honeywell 0 psid to 1 psid ASCX01DN. The pressure transducers have six pins (labeled 1 to 6 on the device) for connecting wires and two ports (A and B) for connecting tubing. The pins needed for this method were pins 2, 3, and 4. The other pins do not need to be connected to anything. Pin 2 is connected to a positive voltage, pin 3 is connected to the data logger's white wire, and pin 4 is connected to a ground.

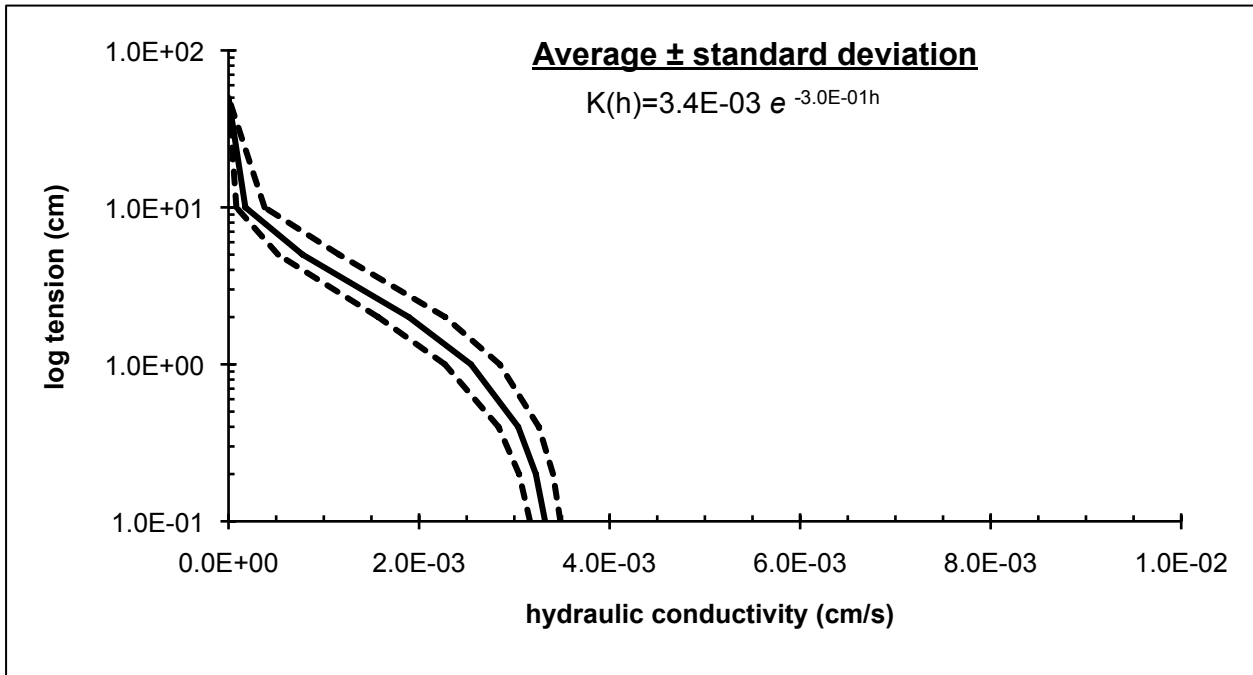
D1. Southwest Area Park

Below are the hydraulic conductivity as a function of tension equations and the graphed curves of those equations. Graphs were made for each individual measurement, and also for the geometric average and standard deviation of all measurements at a site. Each page lists the site number (corresponding to site names listed in Appendix B). Measurements for which saturated hydraulic conductivity calculations were impossible (see section 5.2) have been omitted, so some sites have fewer than four graphs.
