Appendix B. Problems encountered in the field and possible solutions

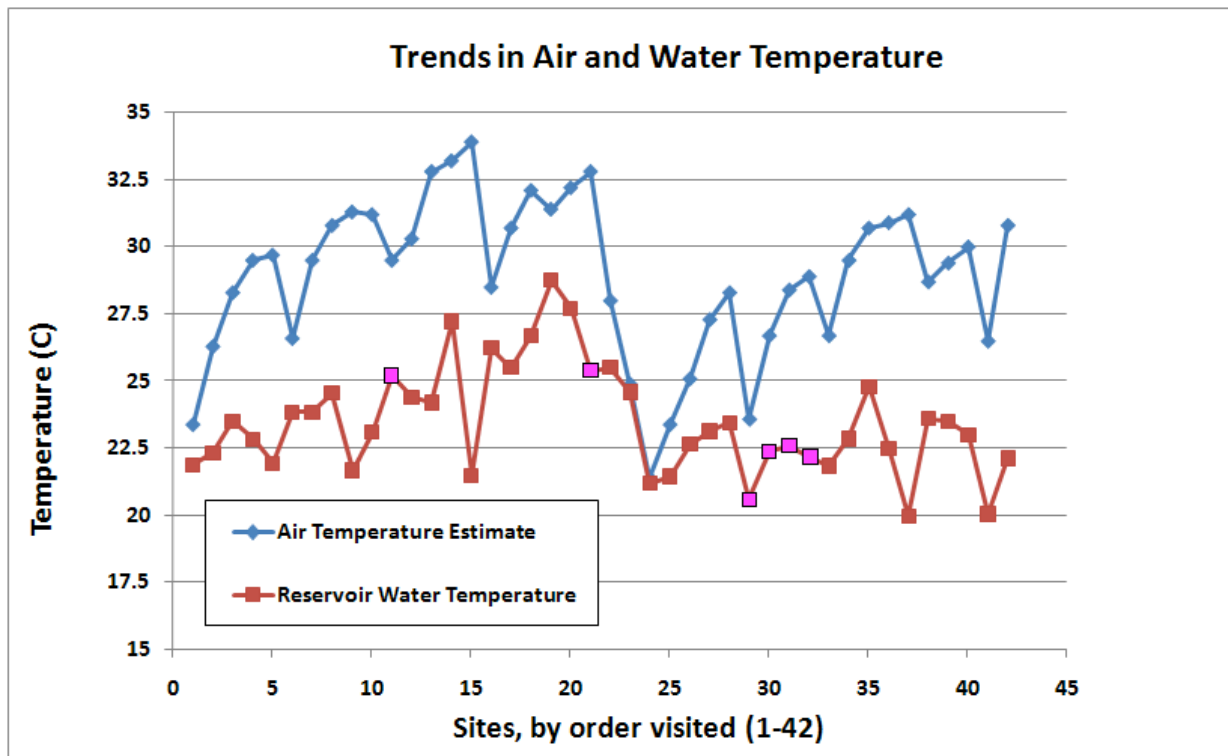
A plot of air temperature (based on the weather station data) vs. measured water temperature data is displayed below (Figure B1). The six sites listed above and their corresponding water temperature estimates are displayed as pink squares, outlined in black. The sites are listed in the order in which they were visited rather than by date and time to increase readability of the plot. Dramatic declines in air temperature in the plot coincide with the beginning of a new field day, as air temperatures were much lower on the following morning than they were in the late afternoon of the previous day. Differential heating of the stream water (which was used to fill the permeameter reservoirs) based on size of the stream, position of the stream in the watershed (headwaters vs. downstream), or canopy cover was not considered.

Figure B1. Weather Station air temperatures and measured stream water temperatures.

For each of the thirty-six sites having accurate water temperature data, air temperature data from the above weather station (updated every five minutes) was determined, and the difference between the air temperature and the measured water temperature was calculated. On average, water temperatures at the thirty-six sites were 5.5°C less than air temperatures. The data was broken up into categories based on the time of day, as the air and stream water temperature differential increases during the course of the day. The following averages were determined:
