FATIGUE AND PROOF TESTING OF AN AIRCRAFT AUXILIARY FUEL TANK

In this study the structural performance of an aircraft auxiliary fuel tank was examined through an experimental program comprised of monotonic and fatigue loads. The study was conducted to insure compliance with the Federal Aviation Regulations (FAR)s and to assess the tank's reliability in terms of its resistance to fatigue damage and over-pressurization failure. In the past, the tank's fatigue design was based on a safe-life concept. The primary goal of this experimental investigation was to demonstrate that the current tank design meets the performance requirements outlined by the FARs for an unlimited service life. To achieve certification for an "unlimited service life" the tank's life must exceed the expected life of the aircraft.

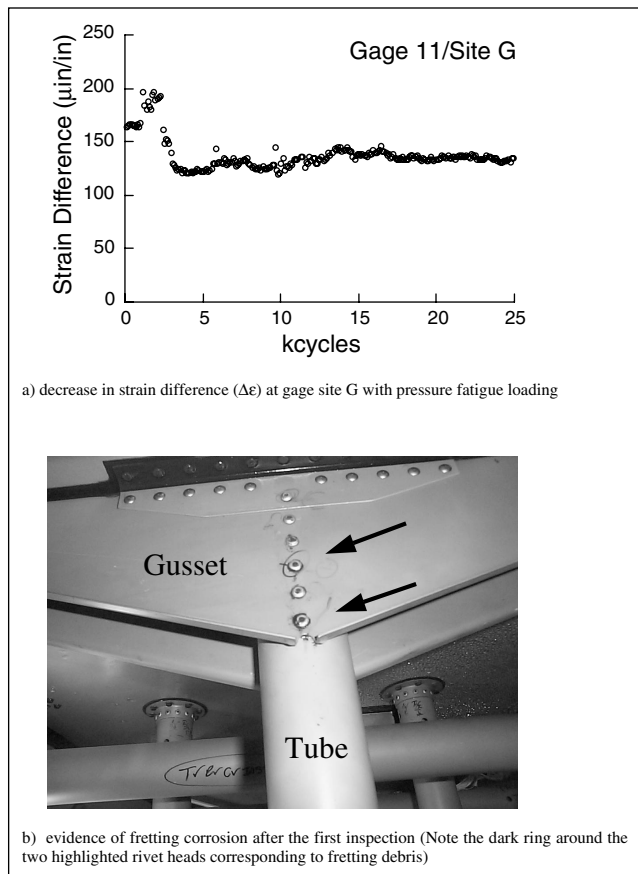
Fig. 4: Change in strain difference with fatigue loading and evidence of fretting fatigue at an integral joint between a vertical tube reinforcement and gusset
